ACCIDENT

REPORT

Reference A-12 Accident Report

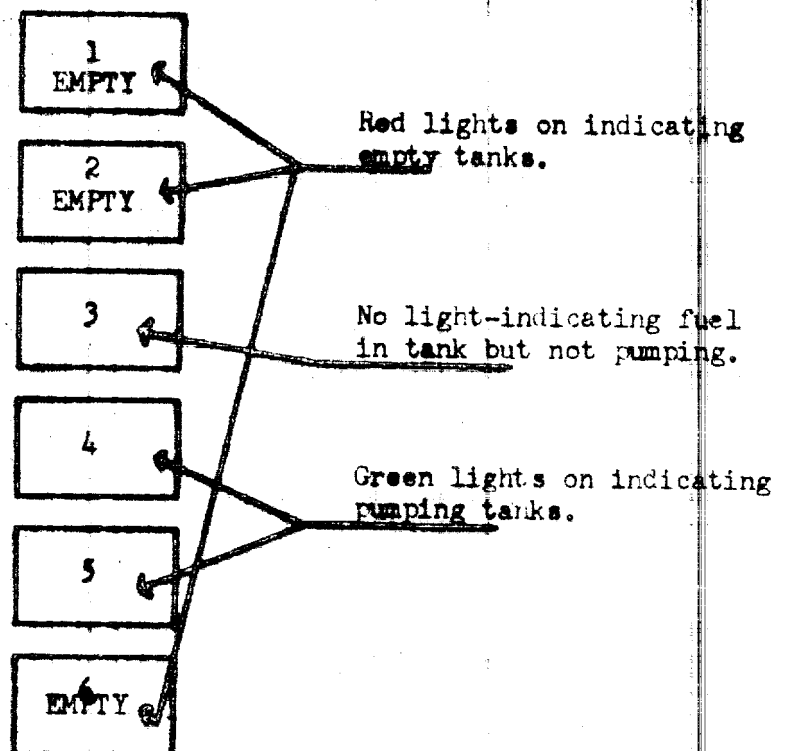
3. Fuel system condition at the time of the accident: The only indications of fuel system performance at the time of the accident come from the pilots comments. Since the "low fuel pressure" lights on the annunciator panel were not illuminated. It is reasonable to assume the fuel pressure to the engines was above 7 psig. In normal operation this pressure would be expected to be 26 - 30 psig. The pilot had good fuel system pumping indications. At the time of the accident the fuel panel was read as follows:

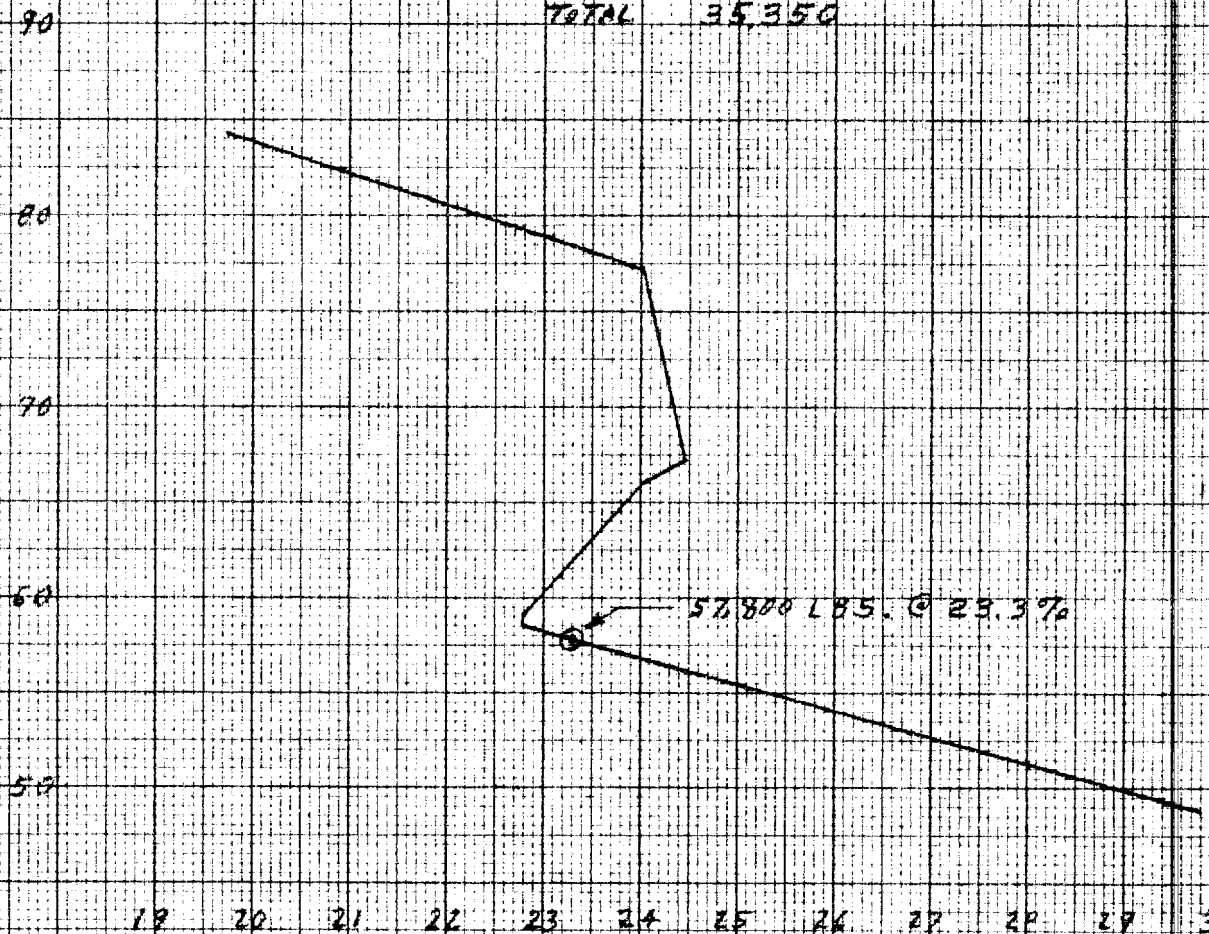
FIGURE 8

b. The pilot reported the fuel system was operating properly. Tanks 1, 2, and 6 had emptied in their normal sequence and tanks 4 and 5 were operating. Tank #3 had not yet started. **One hour fifty-nine minutes** after takeoff the pilot reported 9500 pounds of fuel remaining. Since this reading was taken with the fuel quantity selector switch in the "total" position, it is not considered as reliable as it would have been had the individual tank quantities been recorded. However when existing corrections are applied, 9500 lbs. indicated becomes 10,400 pounds calibrated. It is estimated the aircraft burned approx 1400 lbs of fuel in the nine minutes prior to the stall, leaving 9,000 pounds of fuel on board. This would bring the gross weight to 57,796 pounds and the aircraft C.G. to 23.3% as shown on Figure 8.

When the above point is plotted on the mission curve of gross weight vs C.G. position, it falls in an area where only tank #3 would normally be operating. This discrepancy amounts to 1325 pounds, i.e., at a gross weight above 59,121 pounds, tanks 4 and 5 would be operating together. The reasons for this discrepancy are probably twofold. The normal ullage circuit pumps approximately 900 pounds from tank #3 early in the flight, and, the gauging error with the selector switch in the "total" position could easily be 500 pounds.

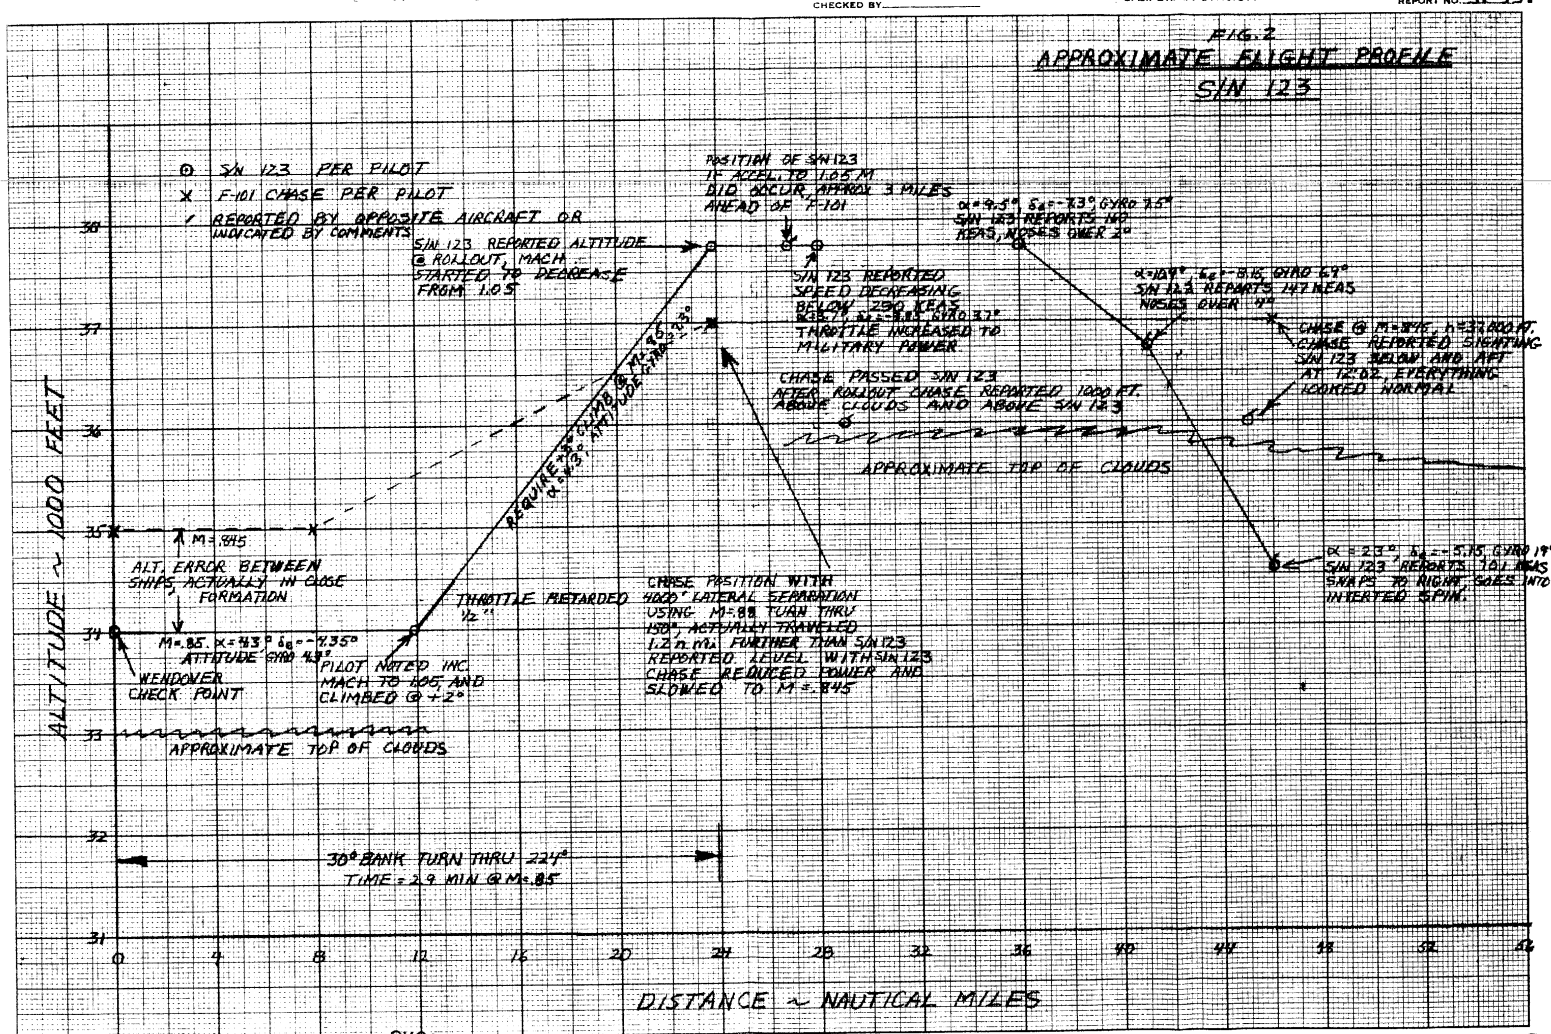
FIG. 2

Figure 2 presents the approximate flight profile of S/N 123 and the chase plane. This figure reflects the reported positions per the individual aircraft's instruments, as well as the reported relative positions of the vehicles. It is to be noted that the elevator angles specified in Figure 2 would be trim positions.

position is an incremental +10 degrees from the required trim position at the last reported speed just prior to the stall and inverted spin. Thus, if this trim position actually existed prior to the stall, there existed a pitching moment equivalent to +10 degrees elevator, which would have tried to nose the aircraft over into a -.5 "g" pushover. A pushover of this magnitude would develop a descent angle at the rate of 10 degrees a second at 101 KEAS at 30,000 feet. A descent angle of 10 degrees, combined with Military power and the drag at -.5 "g's", would have resulted in an acceleration even at 101 KEAS. It can, therefore, be concluded that the trim actuator input was being counteracted by pilot input. The above conclusion is further substantiated by the fact that the autopilot, when in the Auto-Nav mode, utilizes an attitude hold mode in the pitch axis; thus, the autopilot would be putting in nose down elevon to oppose the buildup in angle of attack due to the deceleration. When the autopilot is disengaged with the CSC button, the Mach Box would continue to put nose down elevon in with decreasing speed. In terms of stick force, the pilot effort required to counteract the trim actuator input is approximately 20 pounds.

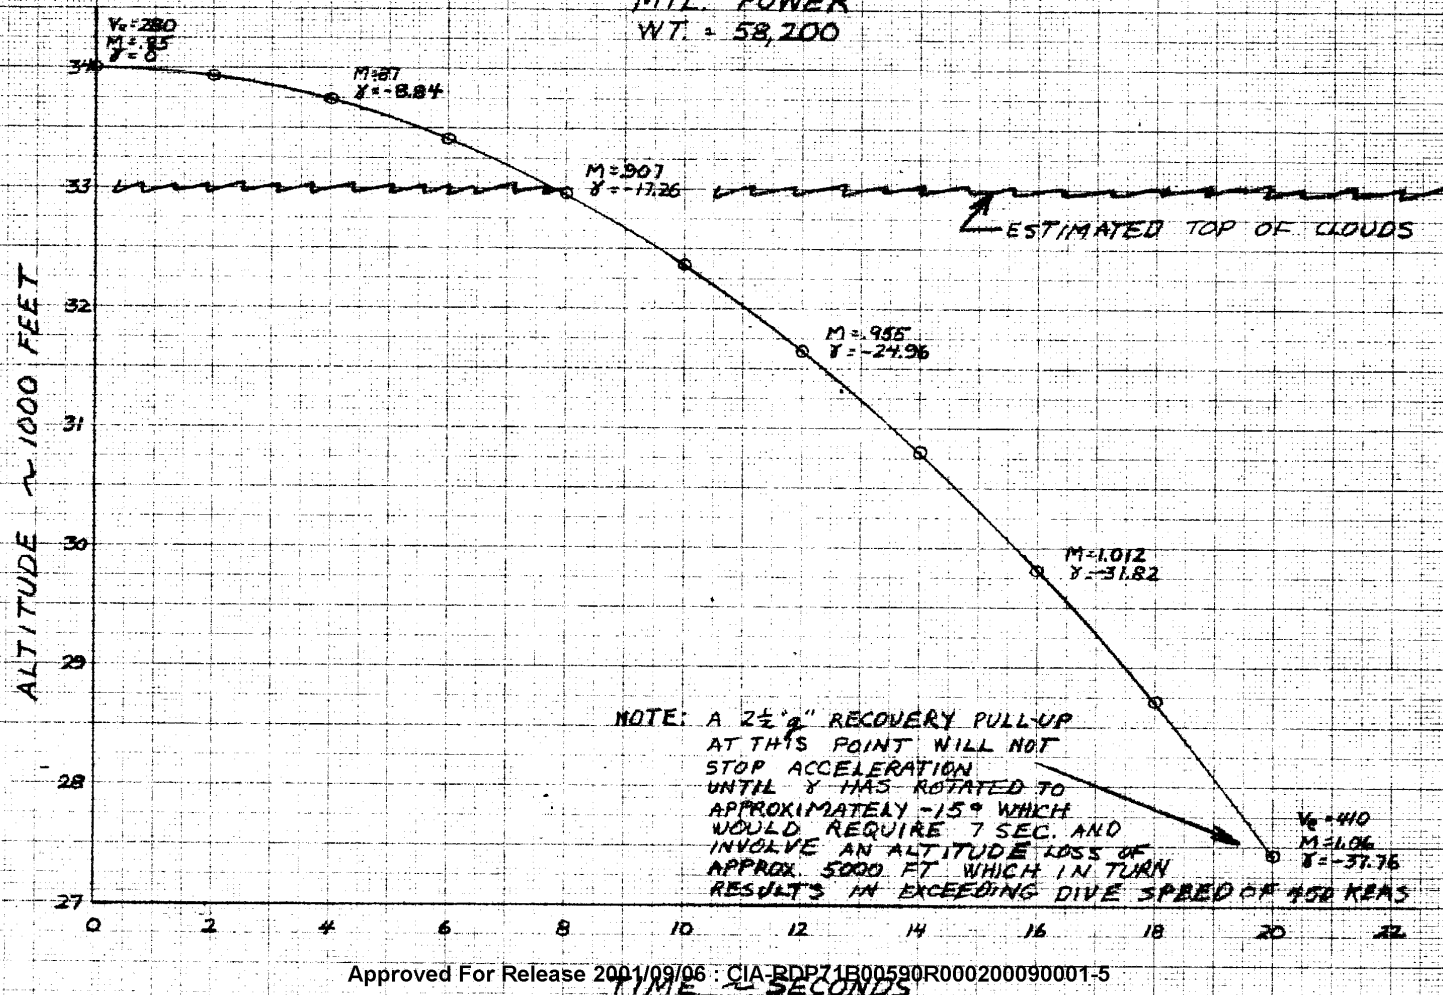
FIG. 3
RAPID ACCELERATION
S/N 123

The resulting flight path, Figure 3, shows that the airplane will accelerate to Mach 1.05 in 19.2 seconds. At Mach 1.05 the flight conditions are:

Both pilots reported an undercast at 32,000 to 33,000 feet. Thus, in order to accelerate to Mach 1.05, S/N 123 would have entered the undercast. During the time that the pilot of S/N 123 reported Mach 1.05, both he and the chase pilot were in visual contact and were above the undercast and indicating 37,000 to 38,000 feet altitude. Furthermore, the chase pilot reported that S/N 123 remained in a normal attitude, and a dive of 10 to 37 degrees would certainly not qualify as a "normal attitude." It is of further interest to note that if the acceleration to Mach 1.05 followed the path shown on Figure 3, and was subsequently followed by a 2-1/2 "g" pullup, the acceleration would continue to increase until the nose down attitude was decreased to 15 degrees and an additional altitude loss of 5,000 feet. At this time the equivalent airspeed would exceed 450 KEAS. The maximum Mach number that could be attained started at 34,000 feet before entering the undercast at 32,000 feet would be 0.95, and the flight path angle would be 24 degrees nose down.

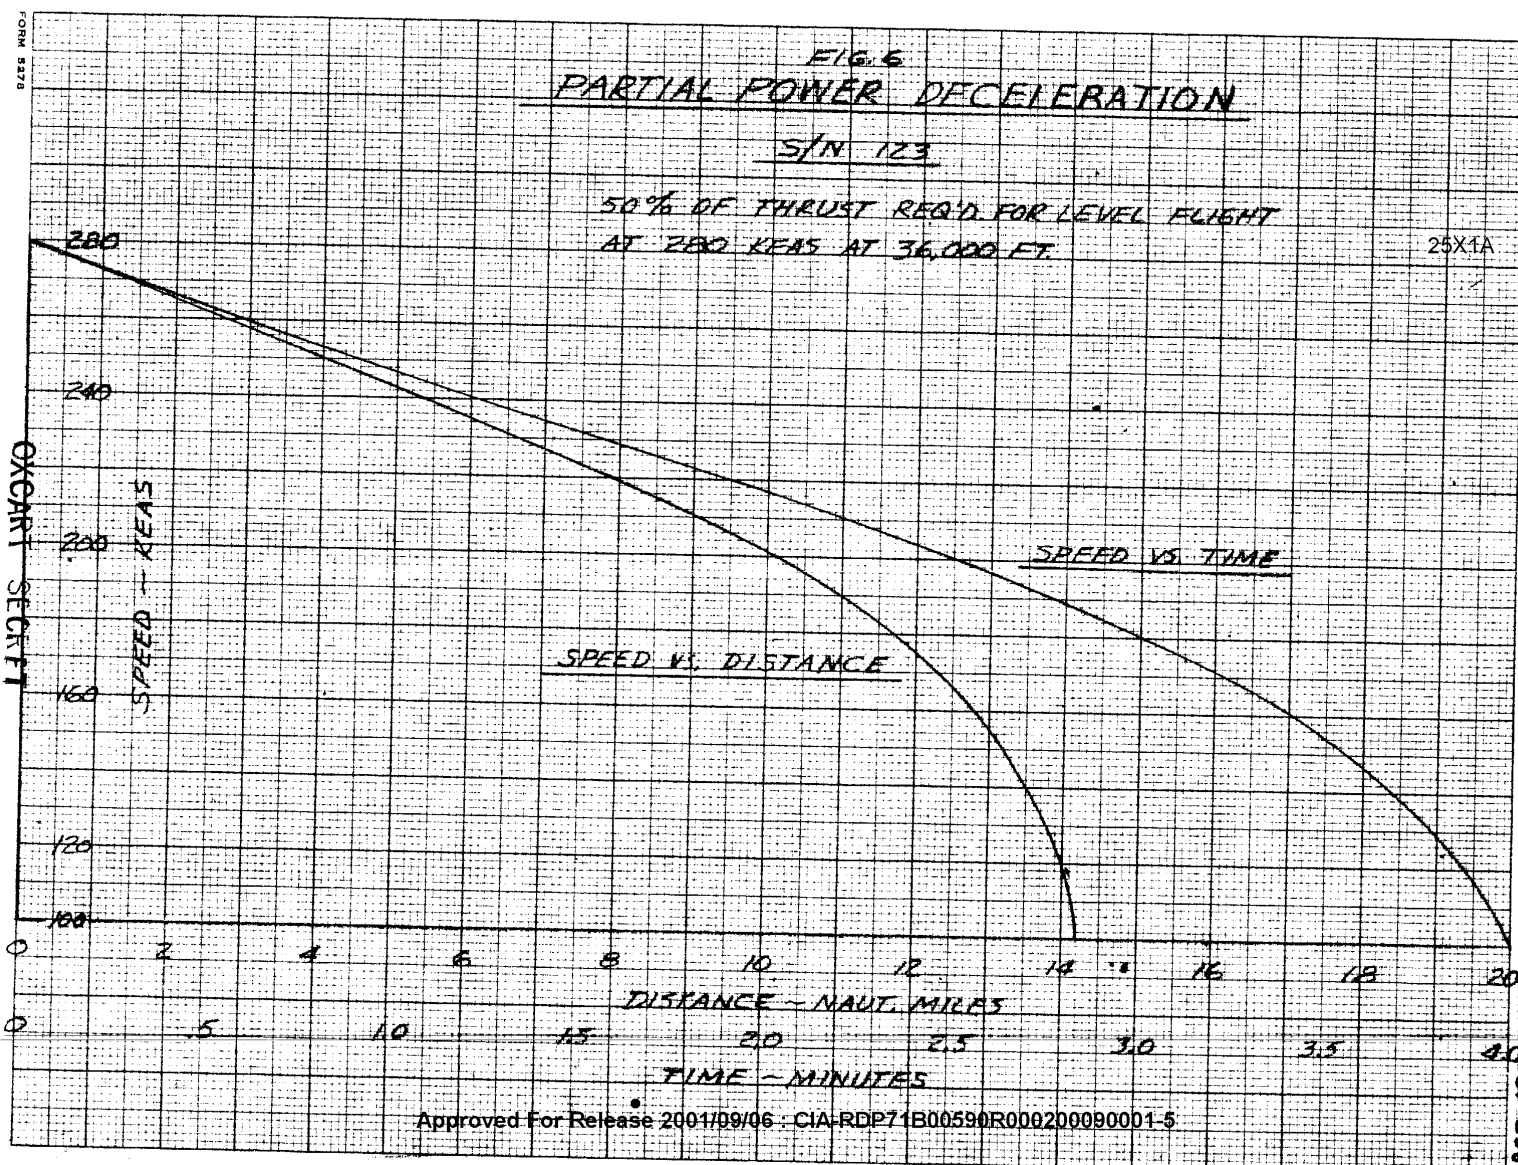
FIG. 5
PARTIAL POWER DECELERATION

The partial power deceleration is shown on Figure 8, assuming that the turn and rollout had proceeded as described earlier and that a 50% thrust loss occurred at 233 KEAS fifteen nautical miles following rollout. Under these conditions, S/N 123 would decelrate to 100 KEAS in an additional eight nautical miles.
